US EPA RECORDS CENTER REGION 5

11-19-96 M. Mikulka  
Gary Development Landfill  
#1 -- Existing bulldozer at site

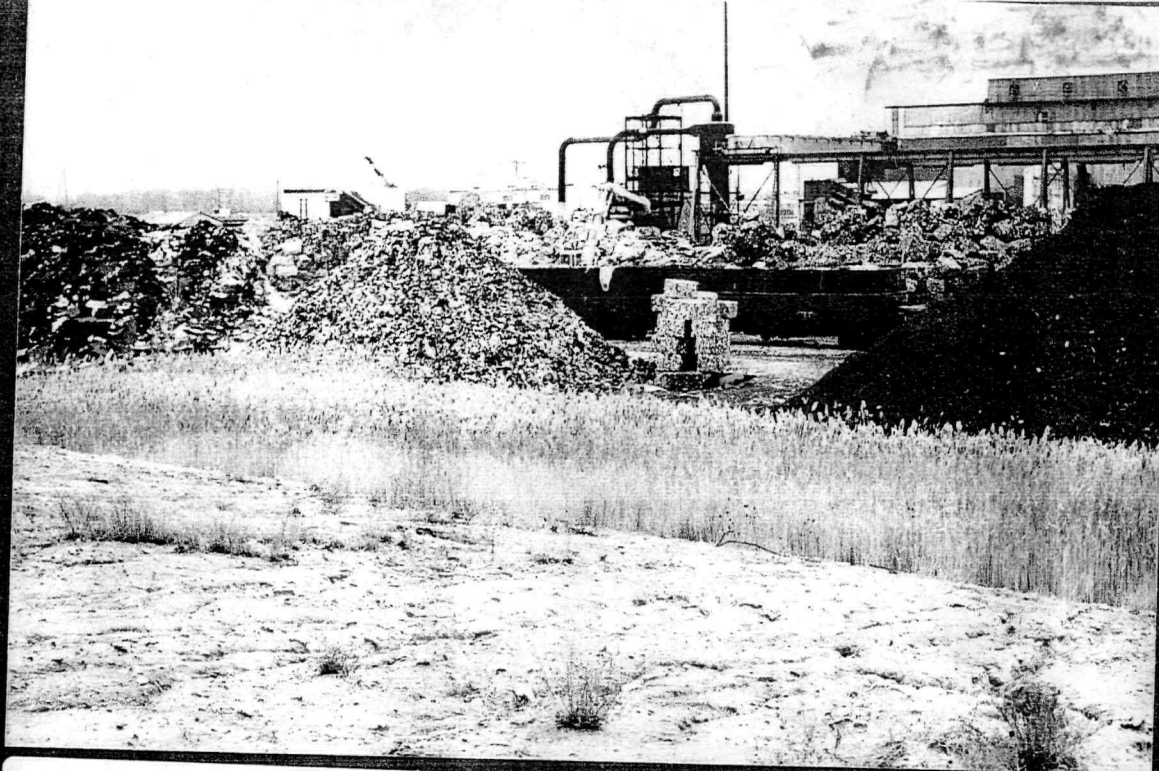
11-19-96 M. Mikulka  
Gary Development Landfill  
#22 -- View of AMG Resources  
facility as seen from W. Side of  
GDC Property. Note western face

of landfill in foreground, and  
depressed area at toe of slope,  
where storm water from western  
portion of landfill drains.
